1400 HAYHIKER TRAINING

Module 1: Chain Routing

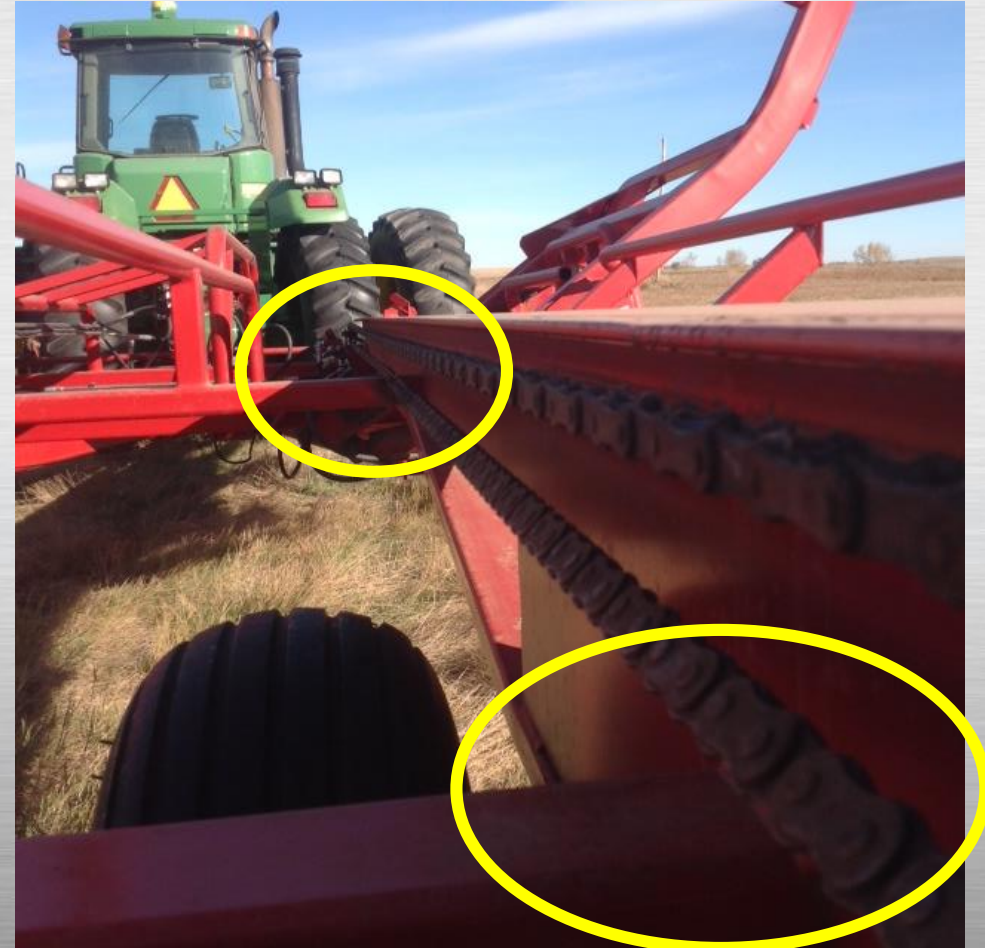
FIGURE 1 – WRONG ROUTING

- The picture on the right shows an illustration of incorrect drive chain routing.
- If routed like this, binding can occur.

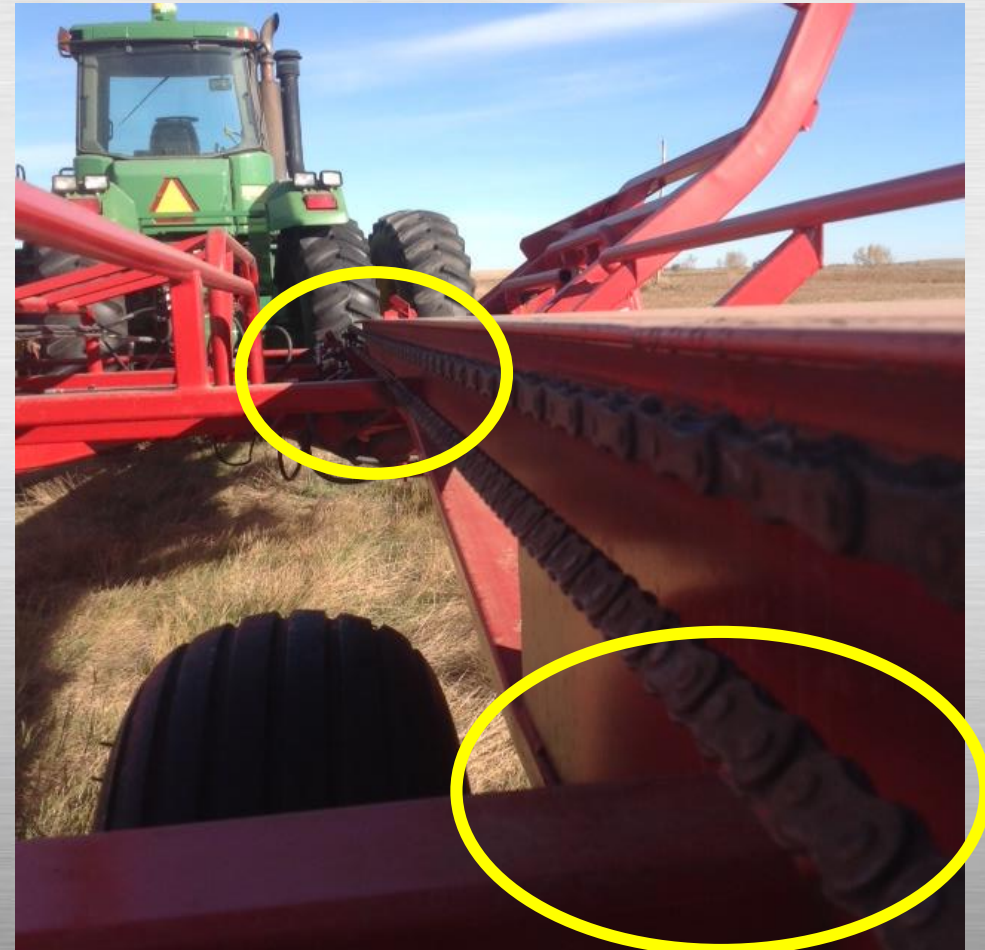
FIGURE 1 – WRONG ROUTING

- Incorrect chain routing in this instance could have occurred right out of the product assembly, and somehow may have also been missed in the dealer PDI.

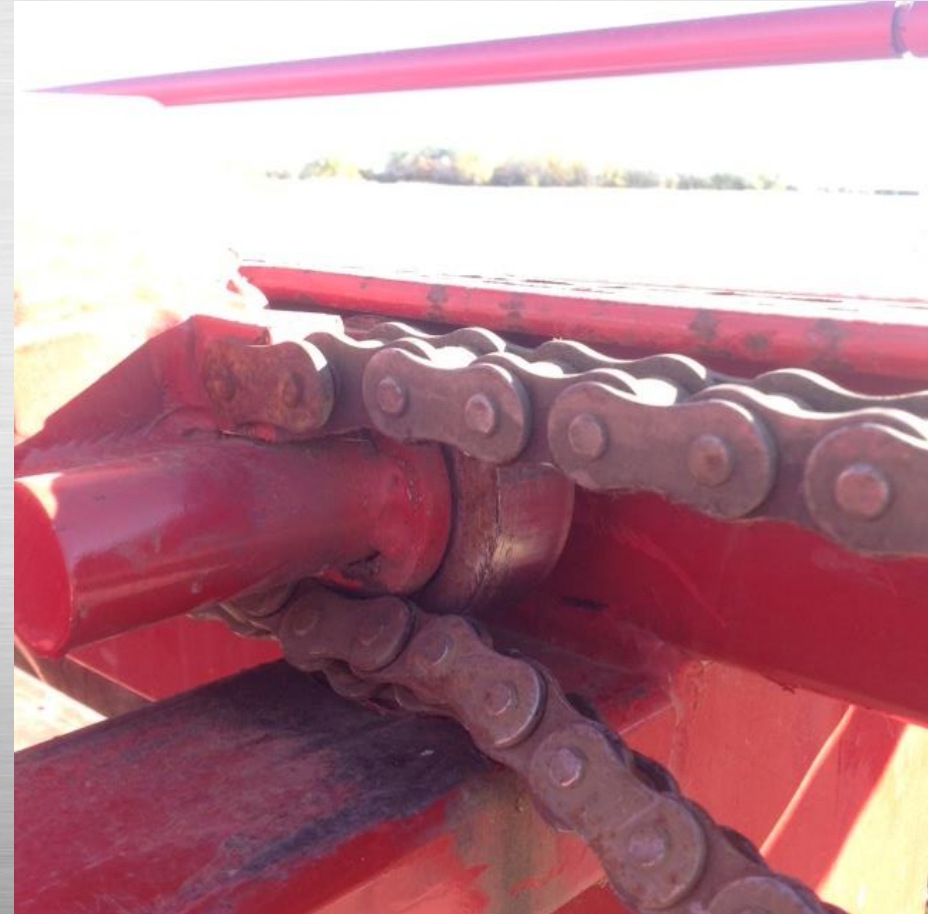
FIGURE 2 – BINDING

- As shown in the picture, incorrect chain routing can risk severe binding leading to function failure.

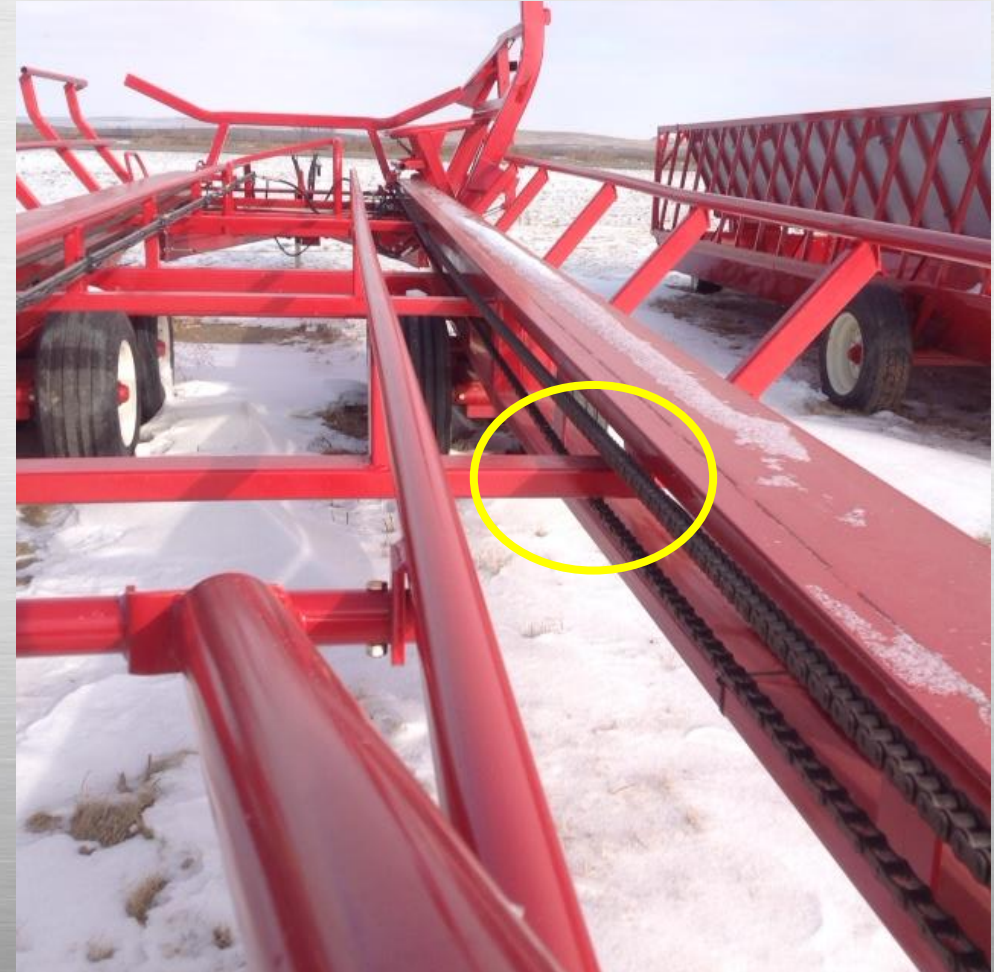
FIGURE 3 – PROPER ROUTING

- With the correct chain routing as shown here, binding will not occur and the chain will move more free and tight to its path.

Currently, the **ONLY** method that should be used is the second one:

- **The decal on the front of the 1400 said to maintain half an inch of clearance from the angle iron strap where the tension bolt goes through to the head of the spring.**
